Manhole Inspection Summary

Manhole # S35M__031MH

Insp Date: **10/16/08 10:41 AM**

Location Address: **700 s. charles st**

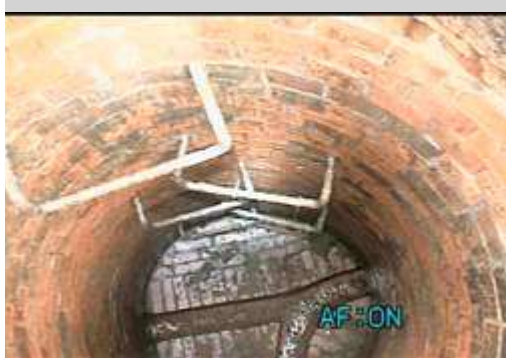
Defect 1

Count: **6** Missing: **0** ☒ **Corroded**

cor. steps

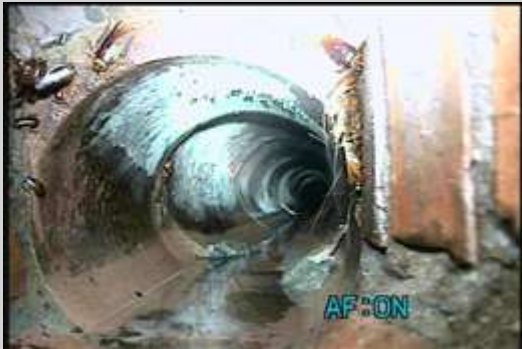
12 O'Clock Outflow

8 in. Circular Gravity Sewer
Pipe Out @ 12 O'Clock

Infiltration: **None** Pipe Seal Cond: **Unknown**

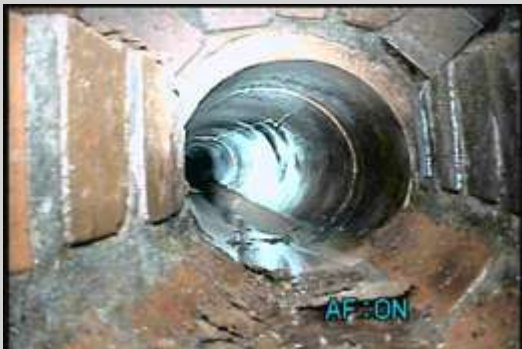
3 O'Clock Inflow

8 in. Circular Gravity Sewer
Pipe In @ 3 O'Clock

Infiltration: **None** Pipe Seal Cond: **Cracked**

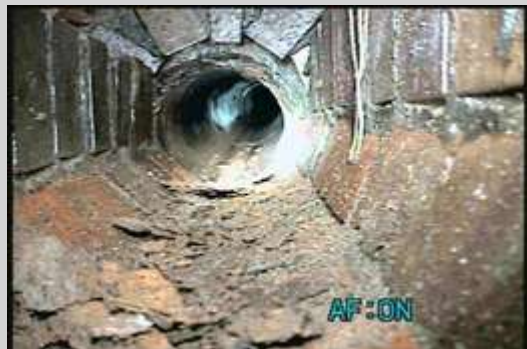
6 O'Clock Inflow

8 in. Circular Gravity Sewer
Pipe In @ 6 O'Clock

Connects To: House connection / Service line
